X20IF1072 导入 EDS 文件后一直报缺失

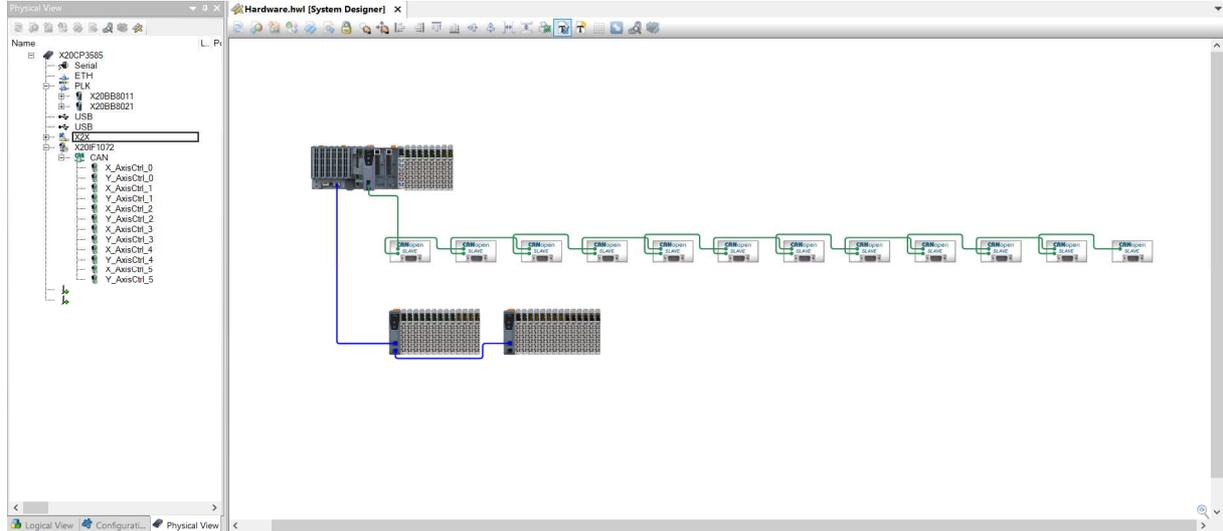
硬件拓扑如下：使用 CP3585+IF1072 带 12 个汇川 SV660C 伺服

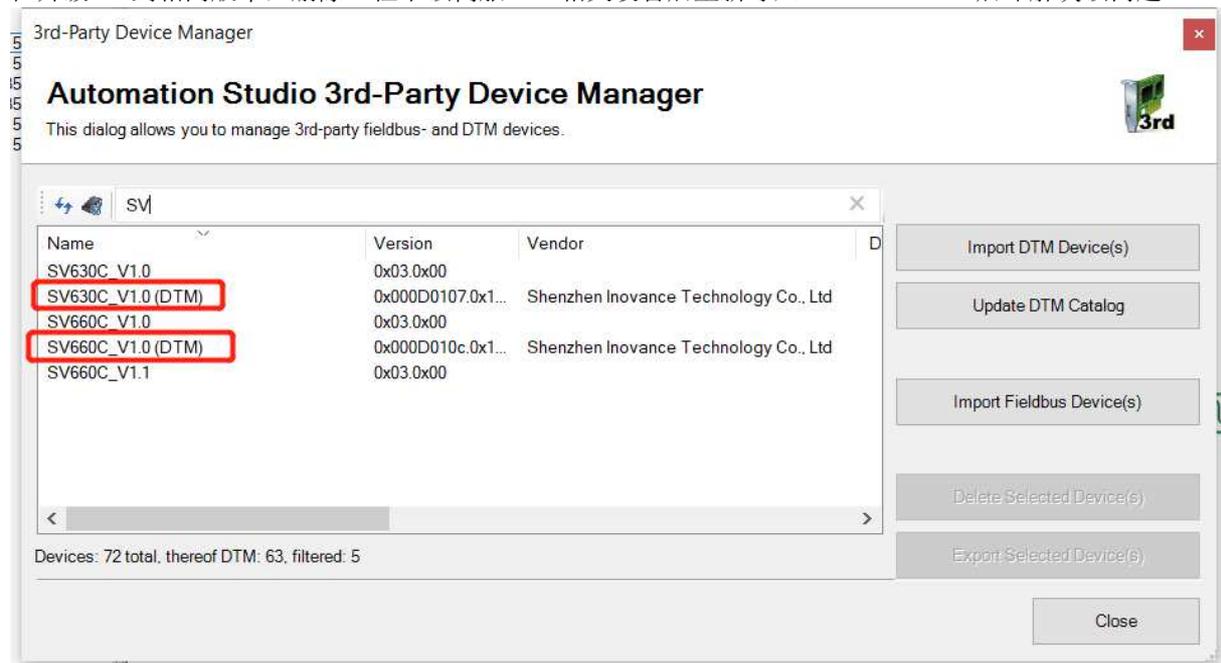
自己电脑的工程拷贝到客户电脑打开后报 EDS 文件缺失，具体如下图：

在升级 AS 到相同版本，删除工程中该伺服 DTM 相关设备后重新导入 Fieldbus EDS 后即解决该问题。
